Structural Conservation Condition Assessment Report

Remaining Farm Building Structures at the former Old Grange Farmyard,
Cooney's Lane, Douglas, Co Cork

Project Number: PB93
 Project Name: Old Grange Farmyard, Cooney Lane
 Client: Mr Tom Falvey
 Document Title: Structural Conservation Condition Assessment Report
 Document Reference: PB93R001 Current Revision: B

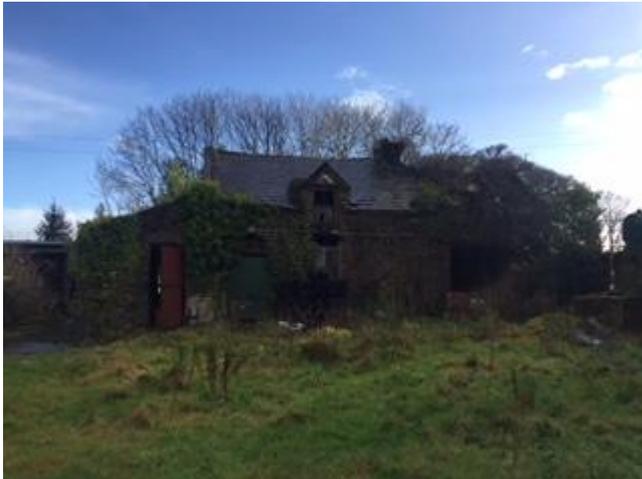
The wall masonry is generally in a poor condition at this time with partial collapse and deterioration of sections of the walls and significant loss of mortar and stone work on all elevations, particularly on the front and rear elevations on the south facing gable walls. The timber window and door frames and support heads have rotten and partly collapsed throughout with subsequent partial collapse and loss of masonry over the openings as seen on the front elevation photo 02 below. The gable walls and rear walls of the structure are leaning significantly and significant cracking and displacement of masonry evident.

Photo 02 – Building (c) Former Farm/Coach House – View of front west facing elevation.

As outlined above this building structure is in a very poor state at this time, if it were to be retained and restored it would require full removal of the roof and internal floors structure, significant partial demolition and rebuild of the existing masonry walls including most of the front and rear wall to ground floor cill level and significant sections of the gable to below first floor level. The retained masonry would have to be re-pointed and grouted with some re build and possible underpinning of the walls.

Given the extend of structure that would be required to be removed and rebuild it may be appropriate to remove the existing structure and rebuild a similar structure along the lines of the original footprint with reuse of salvaged materials as appropriate.

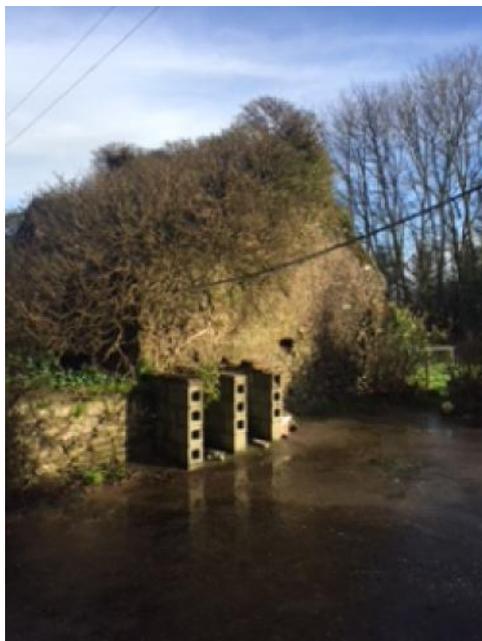
Photo 03 – Southern Gable of Building (c) Former Farm/Coach House

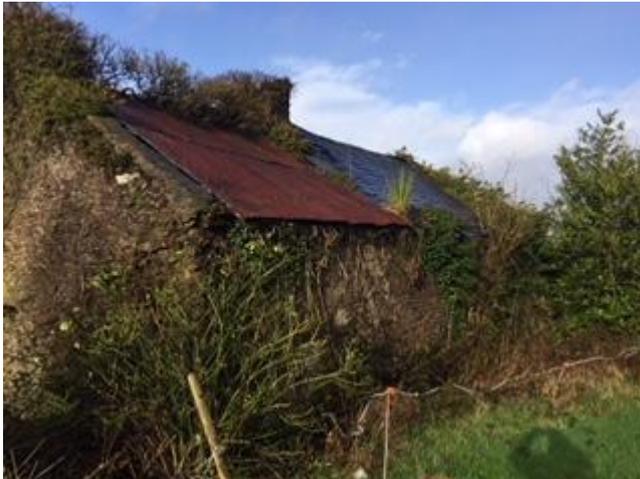
Photo 04 – Rear east elevation of Building (c) Former Farm/Coach House

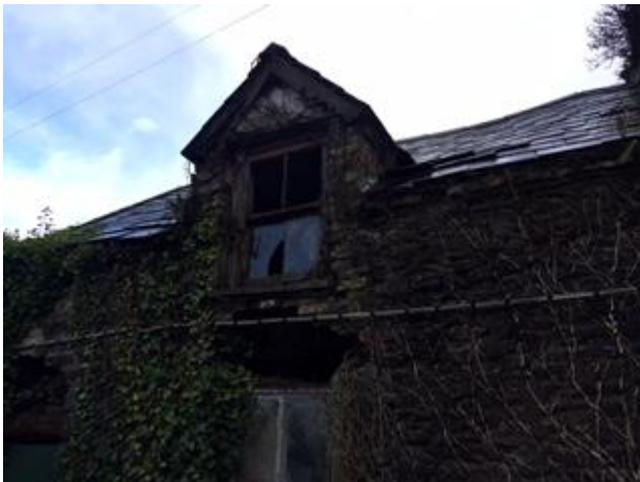
Photo 05 – Building (c) - View of significant collapse wall masonry and roof slate to front of house

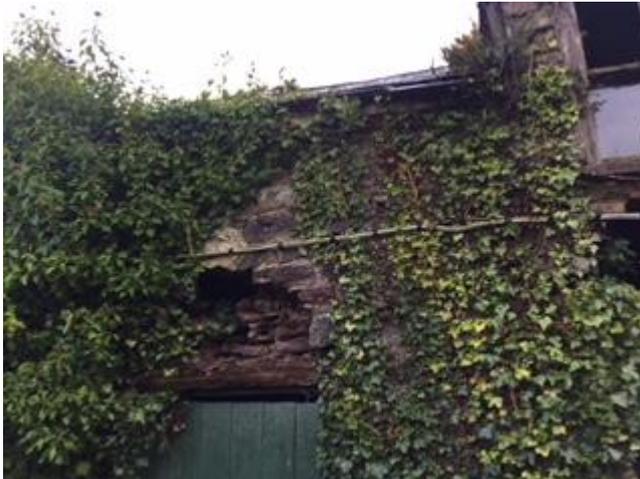
Photo 06 – Building (c) - View of collapse masonry over door head to front of house

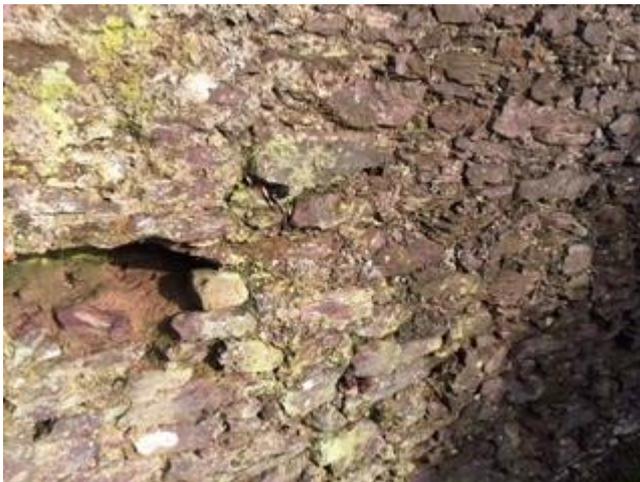
Photo 07 – Building (c) - View of section of missing stonework and mortar loss at southern gable wall. Note mud core to wall construction.

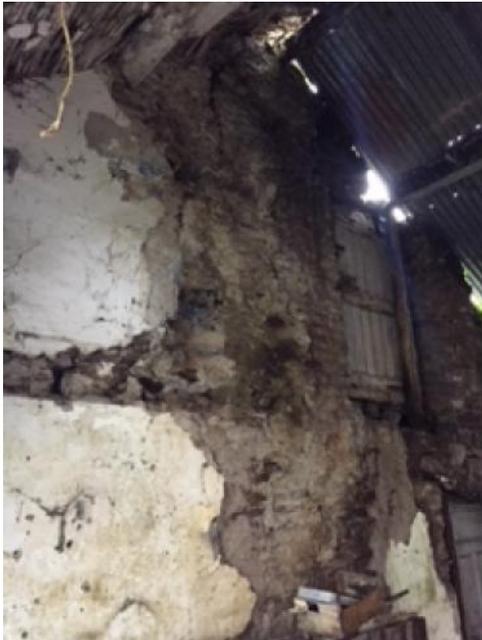
Photo 08 – Building (c) – View of internal wall to southern coach house/stable section of the building. Note the poor condition of the masonry and roof structure.

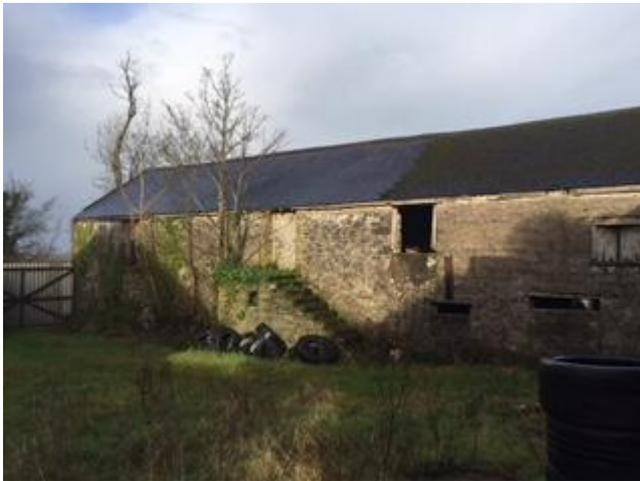
The original structure to the western end of the building is constructed in significant mass stone and brick masonry walls and these are substantial solid built structural walls of circa 600mm thickness. These walls appear to be in a reasonable good structural condition.

Photo 09 – Building (f) Two story farm outbuilding Building– View of Easter end of south facing elevation of late 19th structure.

As outlined above this building was constructed in two phases. The building walls structure to the western end is a mass stone masonry structure and is generally structurally sound and could be substantially retained and incorporated into a redeveloped residential structure. The roof and parts of the upper wall structures would have to be replaced and the walls repaired and repointed and rendered etc.

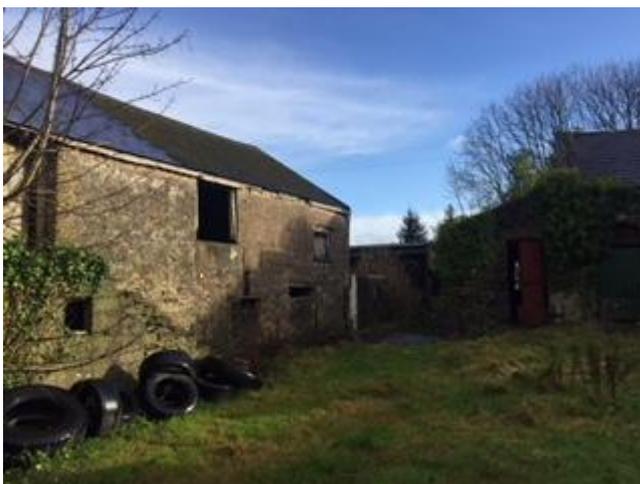
The wall structure to the eastern end of the build is of rubble stone construction at ground floor with a later masonry block construction over at first floor. These walls are in a poor structural condition with significant lean and displacement and cracking on these walls evident. There has been temporary steel ties and channel supports install between the north and south walls of this section of the building to restrain and stabilise the wall structural.

Photo 10 – Building (f) Two story farm outbuilding Building– View of western end of south facing elevation of later possible early 20th century structure.

The later built rubble stone and block masonry structure to the eastern end of this building is in a much poorer structural condition and this section of the building, I would suggest, is of a poor build quality and a less significant structure than the original stone structure. Given this it may be appropriate that this eastern section of the building be removed.

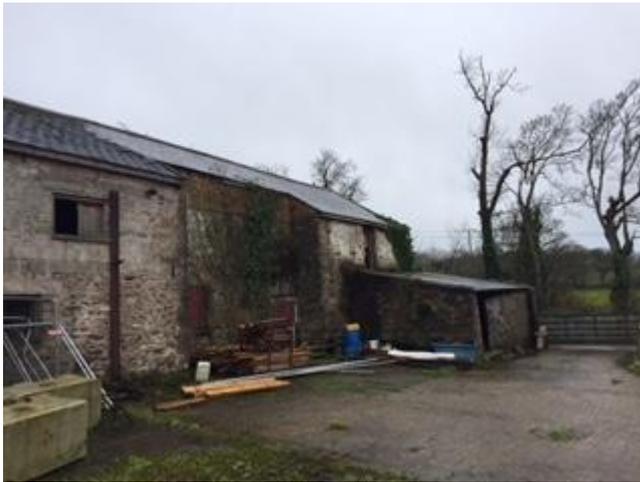
Photo 11 – Building (f) Two story farm outbuilding Building– View of Easter end of north facing elevation of late 19th structure.

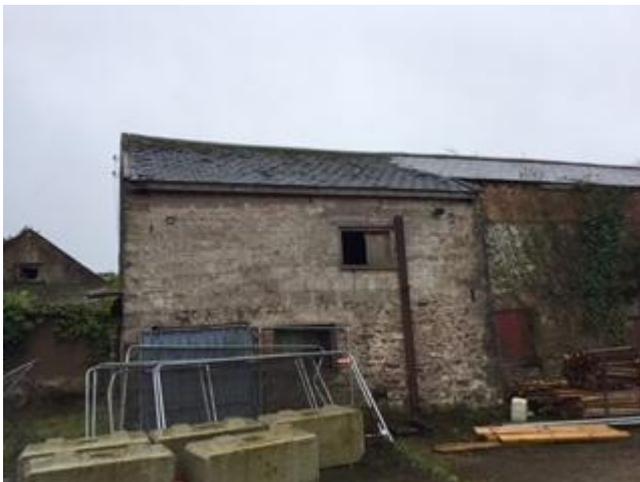
Photo 12 – Building (f) Two story farm outbuilding Building– View of western end of north facing elevation of later possible early 20th century extended block structure.

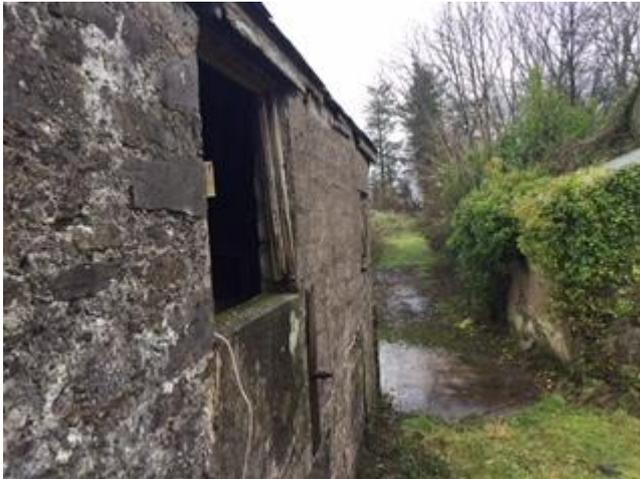
Photo 13 – Building (f) Two story farm outbuilding Building–View of western end of north facing elevation showing masonry block walls and steel plate and tie rod on north elevation.

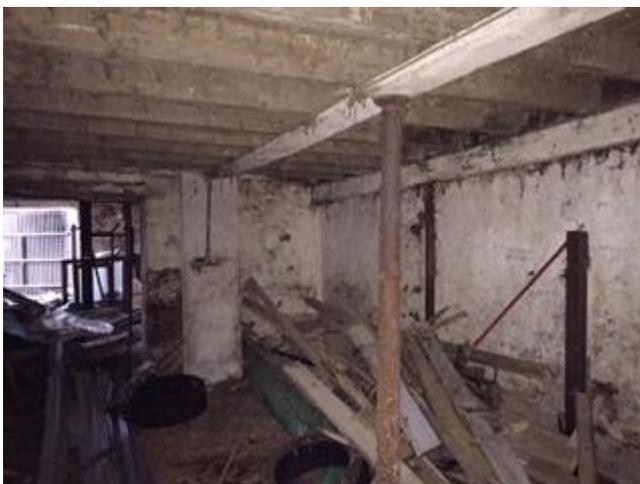
Photo 14 – Building (f) Two story farm outbuilding Building– View of internal ground floor area to western end of building showing lime washed stone wall and underside of suspended timber joist to first floor.

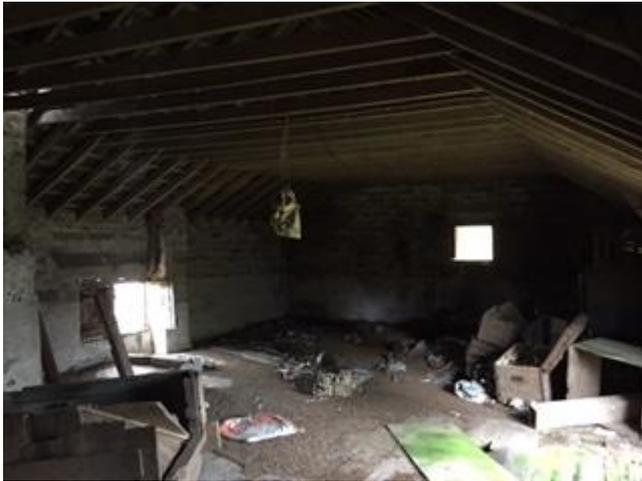
Photo 15 – Building (f) Two story farm outbuilding Building– View of internal 1st floor area to western end of building. Timber roof rafters and exposed blockwork walls visible.

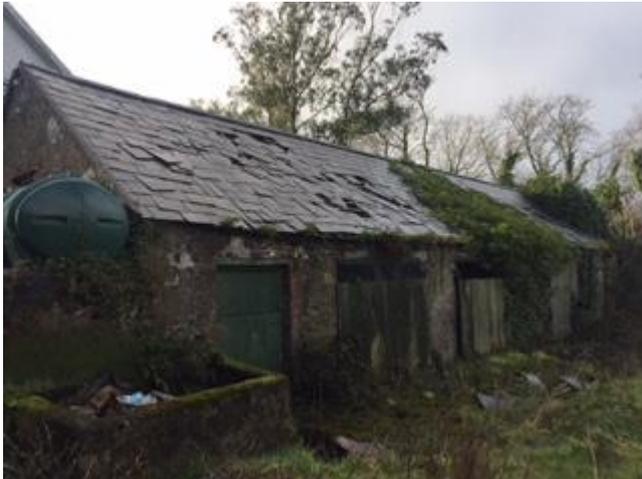
The roof is in a very poor condition with missing slate and rotten timbers.

Photo 16 – Building (e) is a circa 1840 + single story farm labourer's cottage accommodation/outbuildings. View of south facing elevation. Note extensive missing and slipped slate to roof and heavy vegetation growth to building.

This building structure is in a poor structural condition at this time, if it were to be retained and restored it would require full removal of the roof and internal wall and floors structures, partial demolition and rebuild of the existing masonry walls above window head levels including sections of the front (north) wall and upper sections of the end gables. The retained masonry would have to be re pointed and grouted with substantial sections of re build and possible underpinning of the walls. The south and eastern facing walls would have to be tanked externally.

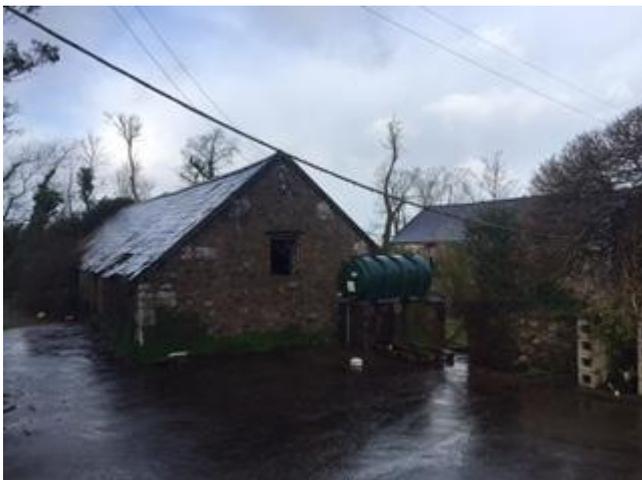
The external ground level to the south and east side of the building are high at circa +1m above the internal floor levels , The roof eaves are low at less than 2m.

Photo 17 – Building (e) is a circa 1840 + single story farm labourer's cottage accommodation/outbuildings. View of eastern gable elevation . Note high ground level and missing and slipped slate to rear north roof surface.

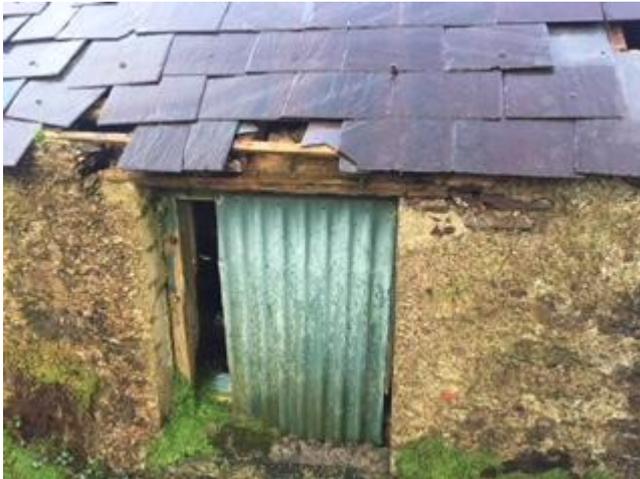
Photo 18 – Building (e) is a circa 1840 + single story farm labourer's cottage accommodation/outbuildings. View of roof and window opening at rear north elevation. Note missing and slipped slate to roof surface and rotten timber head over window ope.

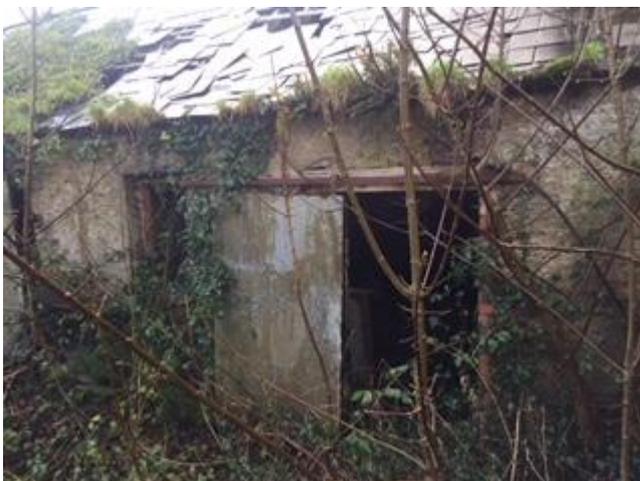
Photo 19 – Building (e) is a circa 1840 + single story farm labourer's cottage accommodation/outbuildings. View of door opening on south elevation to western end of building. Note extensive vegetation to building fabric, missing and slipped slate to roof surface.

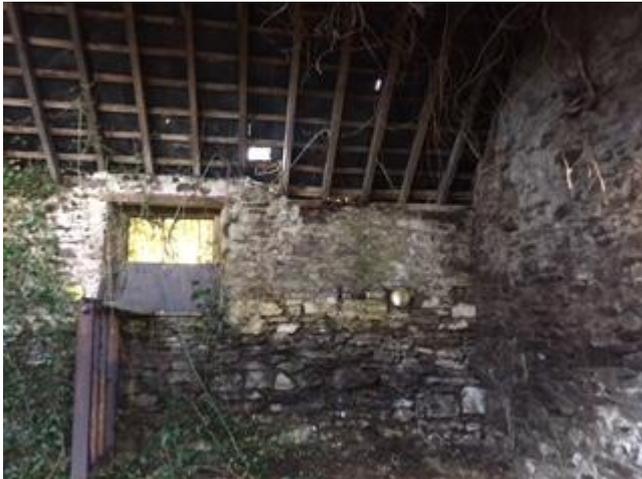
Photo 20 – Building (e) is a circa 1840 + single story farm labourer's cottage accommodation/outbuildings. View of internal north west corner of building. Note loss of mortar joints from stone work, vegetation to building fabric and missing and slipped slate to roof surface.

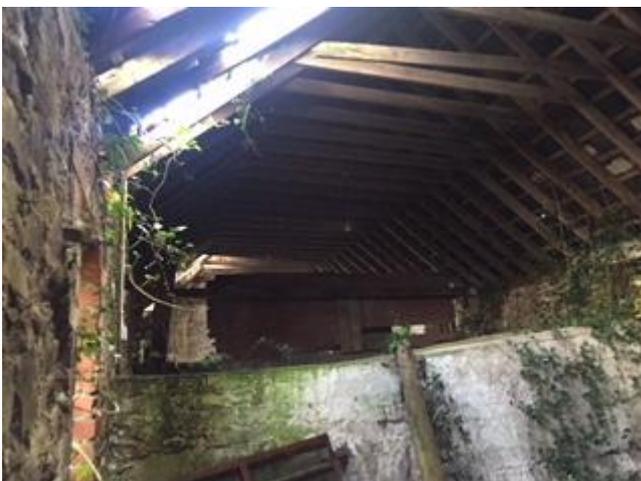
Photo 21 – Building (e) is a circa 1840 + single story farm labourer's cottage accommodation/outbuildings. View of internal building looking east.

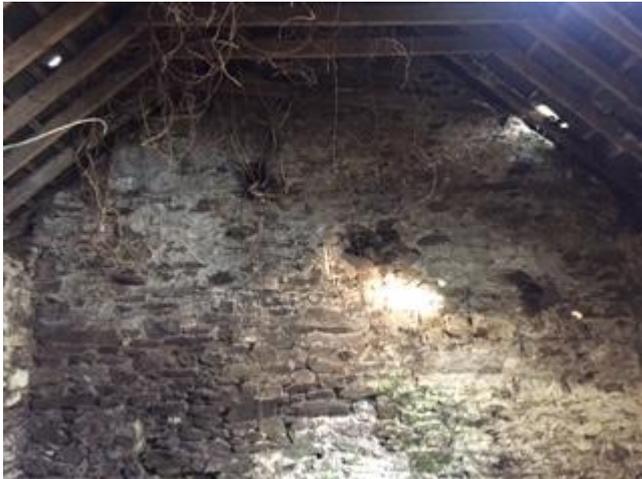
Photo 22 – Building (e) is a circa 1840 + single story farm labourer's cottage accommodation/outbuildings. View of internal western gable wall of building. Note loss of mortar joints and stonework from wall.

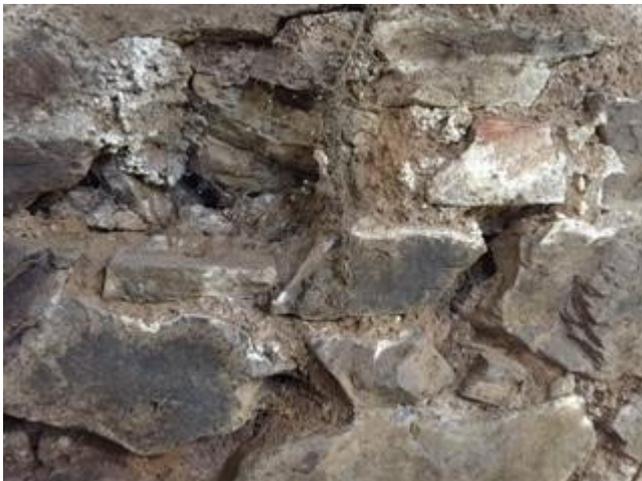
Photo 22 – Building (e) is a circa 1840 + single story farm labourer's cottage accommodation/outbuildings. Close up view of stone work to internal western gable wall of building. Note loss of mortar joints and mud core filling to wall.
